PHASE I ENVIRONMENTAL SITE ASSESSMENT REPORT

39 WEST MARKET STREET (ODD FELLOWS BUILDING)

**GENERAL SERVICES ADMINISTRATION
FRANK E. MOSS FEDERAL COURTHOUSE EXPANSION
PROJECT**

SALT LAKE CITY, UTAH

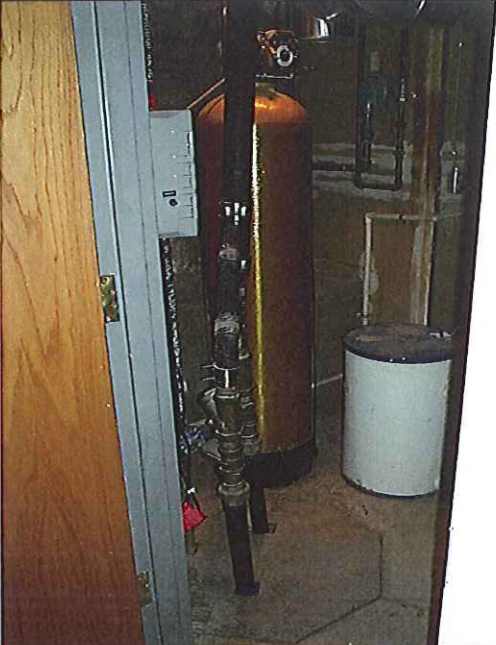
Photographic Record	
Client: GSA	Project: Phase I ESA
Site Name: Odd Fellows Building	
Photograph: S-1

One groundwater sump was observed in the Odd Fellows basement, which serves to maintain the groundwater level below the basement floor. The sump is shown in Appendix B as photos S-1 and S-2. The sump is outfitted with a float-operated submersible pump which transfers accumulated sump water. The outfall location of the sump-derived groundwater was not ascertained.

Photographer: T. Johansen	
Date: 7/11/07	
Comments	Facing north; Odd Fellows sump
Photograph: S-2

- Verify the condition of groundwater in the basement sump. Subsequently evaluate the outfall location of the sump-derived groundwater.
- Further evaluate the existence of ACM and lead-based paint in the subject properties.

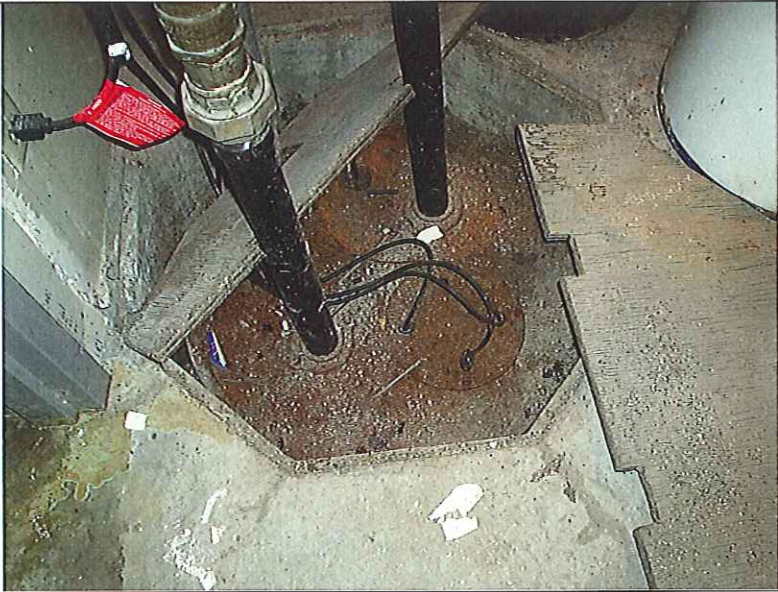
Photographer: T. Johansen	
Date: 7/11/07	
Comments	Facing north; Odd Fellows sump

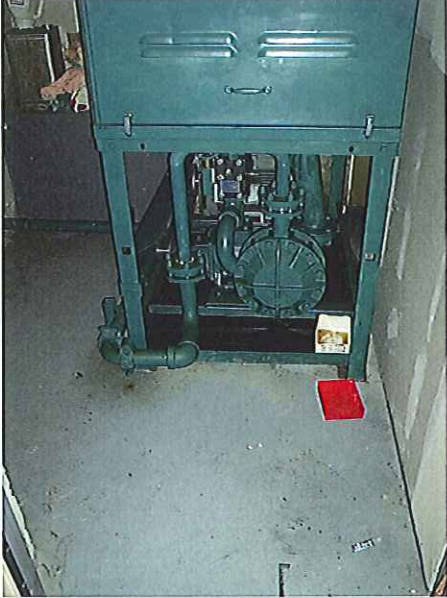
Photographic Record	
Client: GSA	Project: Phase I ESA
Site Name: Odd Fellows Building	
Photograph: S-3

Fluid from the hydraulic motor was observed to accumulate in the drip pan below the machinery, as shown on photo S-3 in Appendix B. No staining was observed on the floor beneath the motor, therefore spills/overflow is not suspected. In addition, the elevator appears to be fairly new, with on Site maintenance records extending back to 1999.

Photographer: T. Johansen	
Date: 7/11/07	
Comments	Facing west; hydraulic elevator motor and drip pan
Photograph: S-4

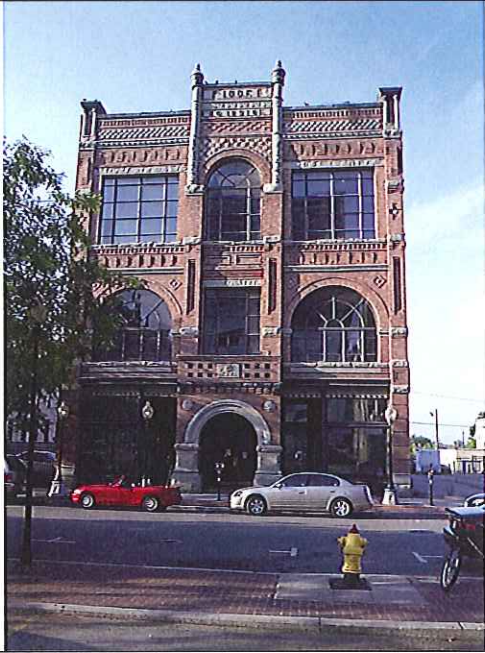
Photographer: T. Johansen	
Date: 7/11/07	
Comments	Facing south; Independent Order of Odd Fellows building

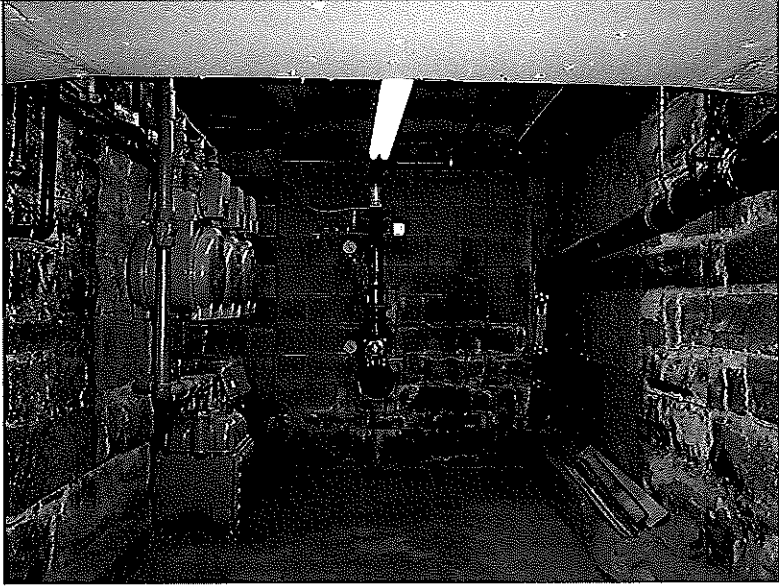
Photographic Record	
Client: GSA	Project: Phase I ESA
Site Name: Odd Fellows Building	
<div>Photograph: S-5</div> <div>Photographer: T. Johansen</div> <div>Date: 7/11/07</div> <div></div>

Comments	Facing south; utilities in Odd Fellows basement
